**Flood Control Project Maintenance
Levee Inspections**

Fall 2013 Levee Maintenance Deficiency Summary Report

Reclamation District No. 0341 Sherman Island

Levee Inspection Report By Mile - Fall 2013

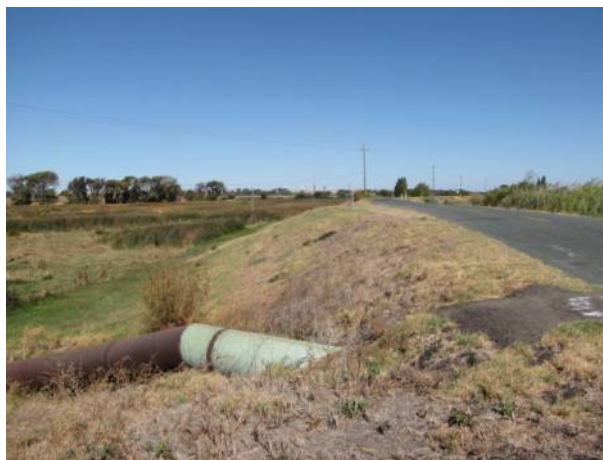
Levee Mile Report Line	4
Start Levee Mile	0.00
End Levee Mile	0.00
Location	Land Side
Category	Earthen Levee
Item	Vegetation

Unit 1 RD 341 Landside looking downstream.
Photo taken 9-17-2013.

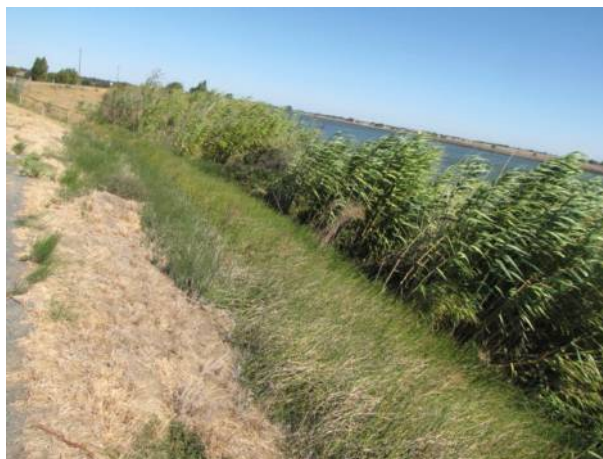
Levee Mile Report Line	5
Start Levee Mile	0.00
End Levee Mile	0.02
Location	Water Side
Category	Earthen Levee
Item	Vegetation

RD 341 Bambo waterside levee mile 0.00. Photo taken 9-17-2013.

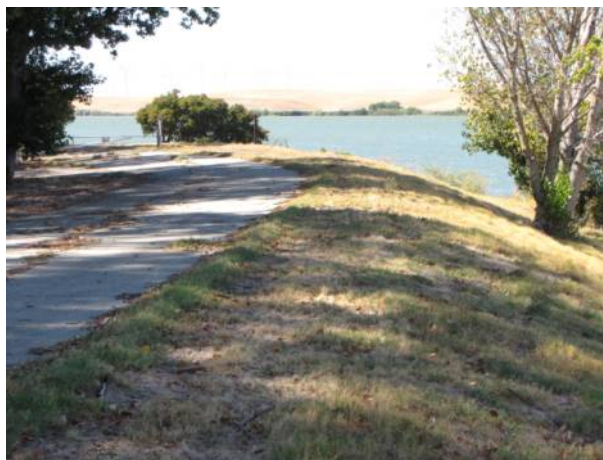
Levee Mile Report Line	2
Start Levee Mile	3.36
End Levee Mile	3.36
Location	Water Side
Category	Earthen Levee
Item	Vegetation

RD 341 Looking downstream from levee mile 3.36 waterside slope Unit 2. Photo taken 9-17-2013.

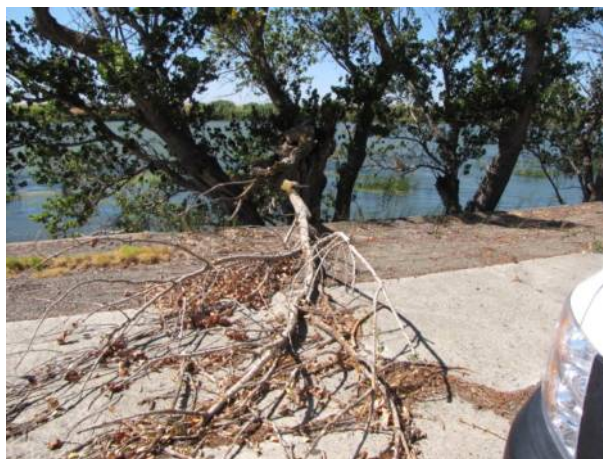
Levee Mile Report Line	3
Start Levee Mile	3.78
End Levee Mile	3.78
Location	Water Side
Category	Earthen Levee
Item	Encroachments

RD 341 Fallen tree limb water ward shoulder/crown. Photo taken 9-17-2013.

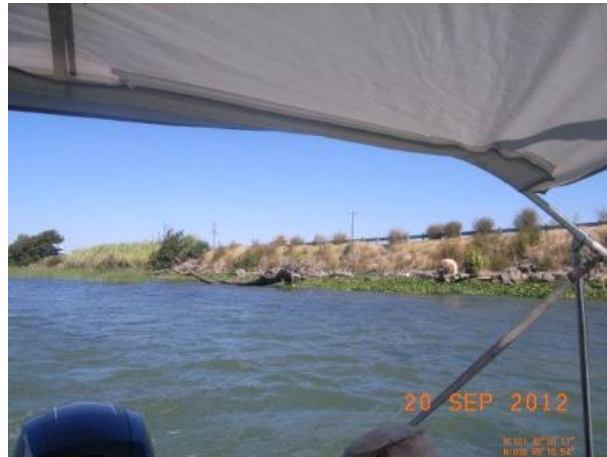
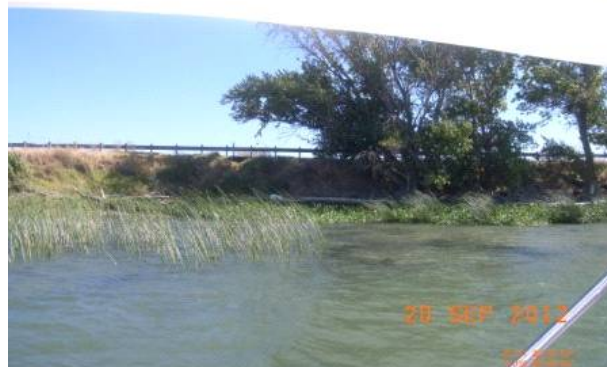
Levee Mile Report Line	10
Start Levee Mile	4.73
End Levee Mile	4.81
Location	Water Side
Category	Supplemental
Item	USACE Erosion Survey

DWR ID:		
10	4.73	4.81	Supplemental	USACE Erosion Survey	WS	U Ma	Inspector Comments: 2011 - Large slump section 2012: Site extended downstream, upgrade to critical, severe windwave. Slope is very steep and may be effecting the highway on top of the levee. [2012 Site ID: SAC_7-9_L]	38.086603 ° -121.707786 °	38.085459 ° -121.708607 °	7 Y
								DWR ID:		
11	5.25	5.86	Earthen Levee	Vegetation	WS	M Ma	V2 : Remove the wild growth other than native grasses from the levee slopes.	38.082194 ° -121.715246 °	38.080228 ° -121.726459 °	2
								DWR ID: DWR_RD0341_02_f_2012_2		
12	5.96	6.09	Supplemental	USACE Erosion Survey	WS	U Ma	Inspector Comments: 2011 - Large slump at downstream end. Gully formed from surface runoff from the road. Shallow slumping throughout site. 2012: The gully at upstream end has increased in size and site continues to worsen. [2012 Site ID: SAC_7-3_L]	38.080370 ° -121.728341 °	38.080526 ° -121.730483 °	8 Y
